# Debris/Ice/TPS Assessment and Integrated Photographic Analysis of Shuttle Mission STS-66

**DEBRIS/ICE/TPS ASSESSMENT  
AND  
INTEGRATED PHOTOGRAPHIC ANALYSIS  
OF  
SHUTTLE MISSION STS-66**

**3 November 1994**

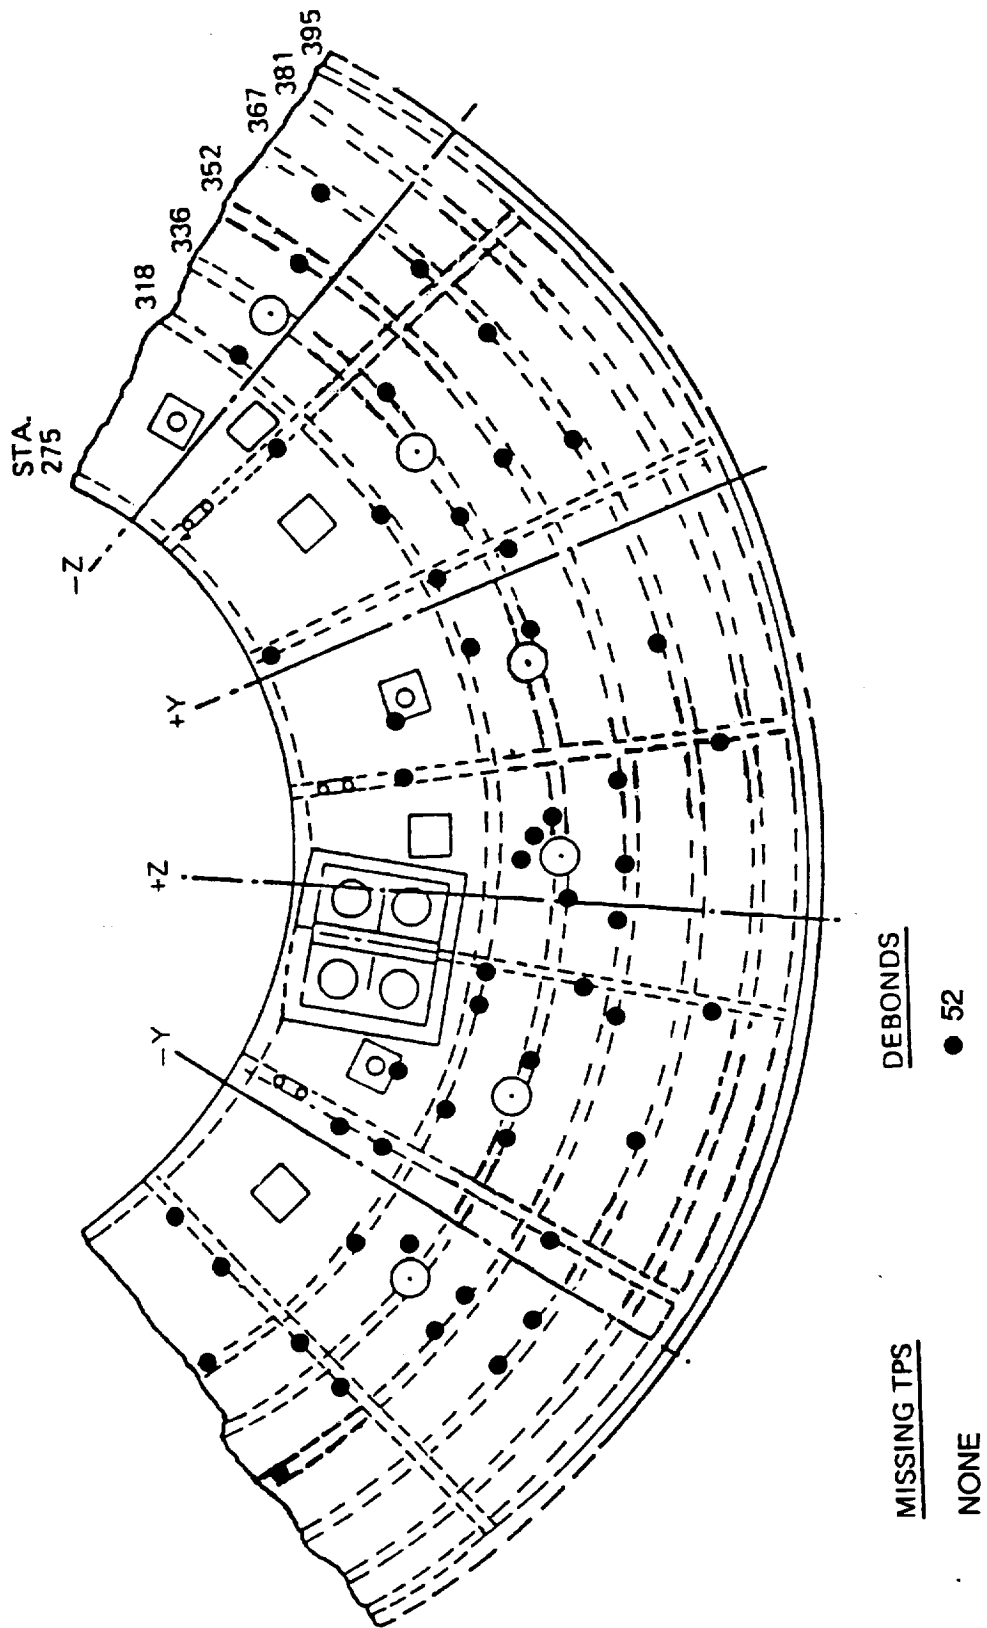
**Figure 1 : RH SRB Frustum**

The RH frustum was missing no TPS but had 50 debonds over fasteners and 2 debonds over acreage (Figure 1). Since the number of debonds was greater than the frustum history average of 25 debonds, a representative set of the MSA-2 debonds were analyzed by MSFC for possible material or processing anomalies (IFA: MSA-2 did not adhere to painted surfaces adjacent to PR 1422-sealant-over-fastener debonds. The problem was traced to an MSA-2 spray pump problem). Hypalon paint was blistered/missing where BTA closeouts had been applied. Some of the underlying BTA was sooted. The BSM aero heat shield covers had locked in the fully opened position.

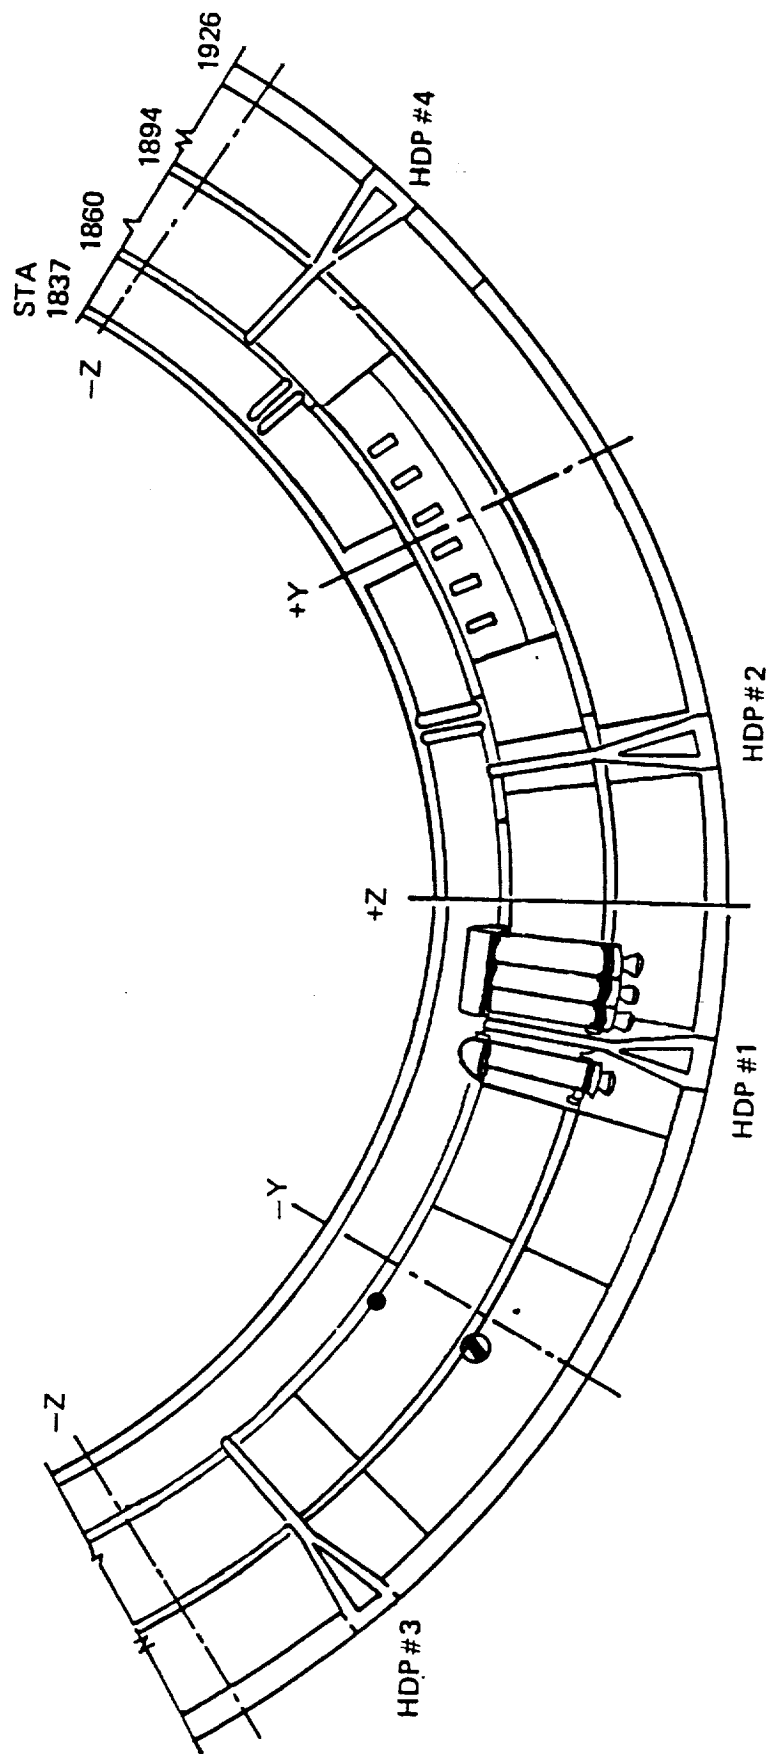
**Figure 2 : RH SRB Aft Skirt**

The phenolic material on the kick ring exhibited minor delamination. Aft skirt acreage TPS was generally in good condition. One MSA-2 debond occurred near the -Y axis at the XB-1860 ring frame. A 2-inch diameter MSA-2 divot was present near the -Y axis at the XB-1894 ring frame (Figure 2). Hypalon paint was blistered/missing over the areas where BTA had been applied. The HDP Debris Containment System (DCS) plungers were seated and appeared to have functioned properly.

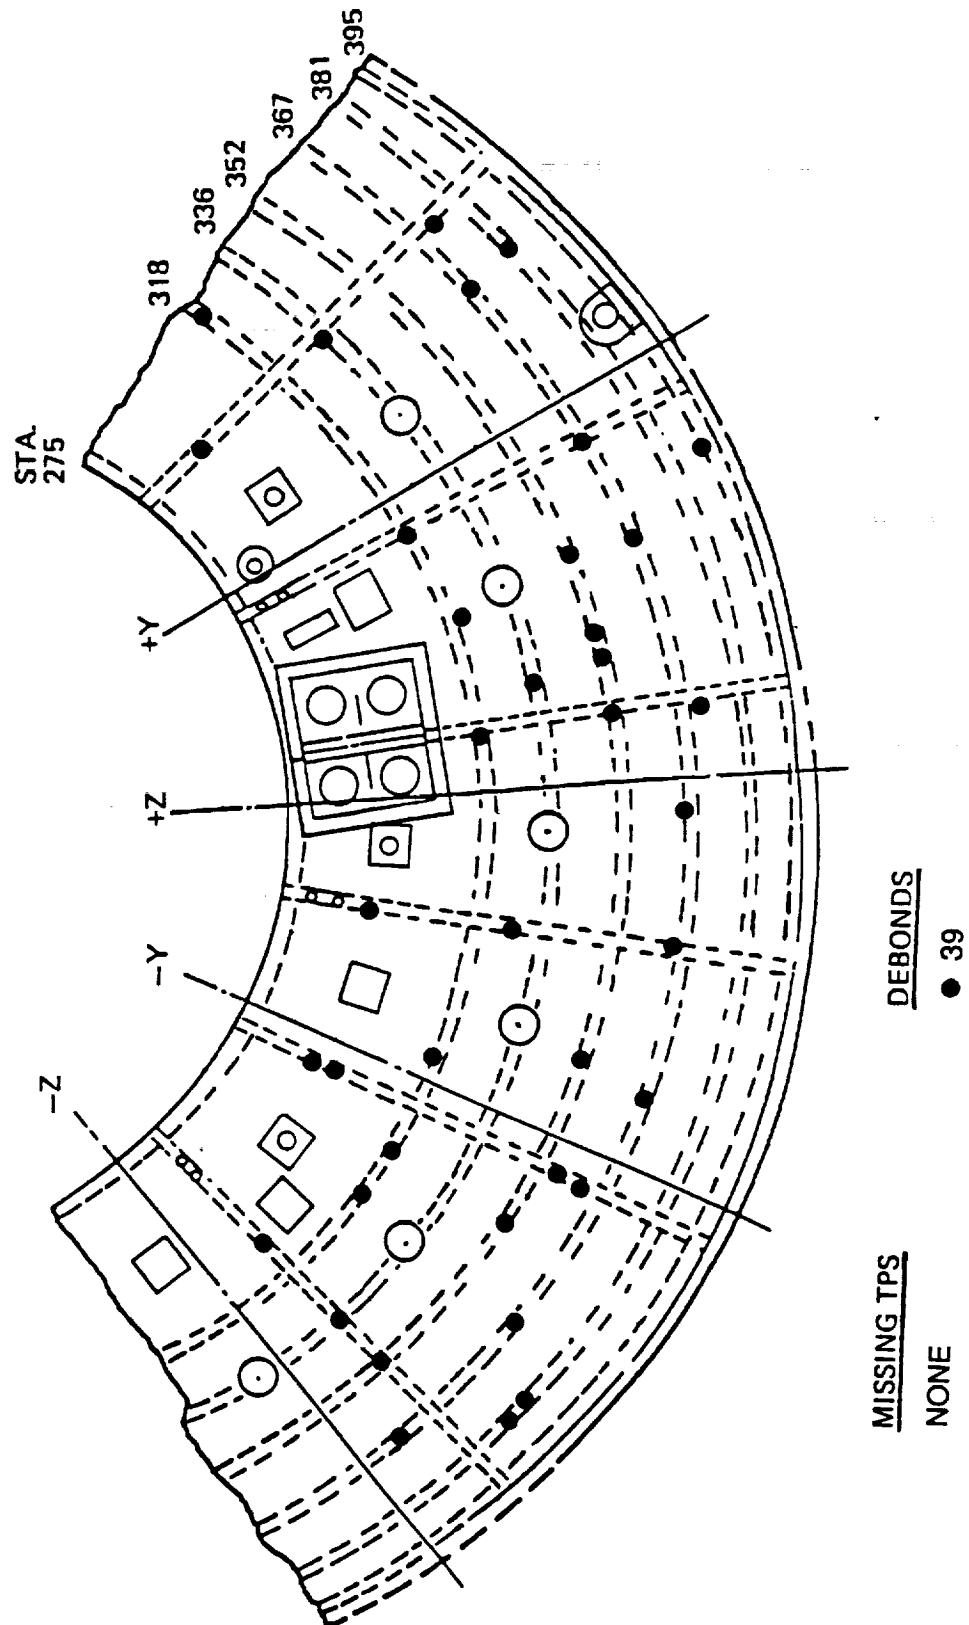
**Figure 3 : LH SRB Frustum**

The LH frustum was missing no TPS but had 39 MSA-2 debonds over fasteners (Figure 3). Since the number of debonds was greater than the frustum history average of 25 debonds, a representative set of the MSA-2 debonds were analyzed by MSFC for possible material or processing anomalies (IFA: MSA-2 did not adhere to painted surfaces adjacent to PR 1422-sealant-over-fastener debonds. The problem was traced to an MSA-2 spray pump problem). Hypalon paint was blistered/missing where BTA had been applied. Some of the underlying BTA was sooted. The BSM aero heat shield covers had locked in the fully opened position.

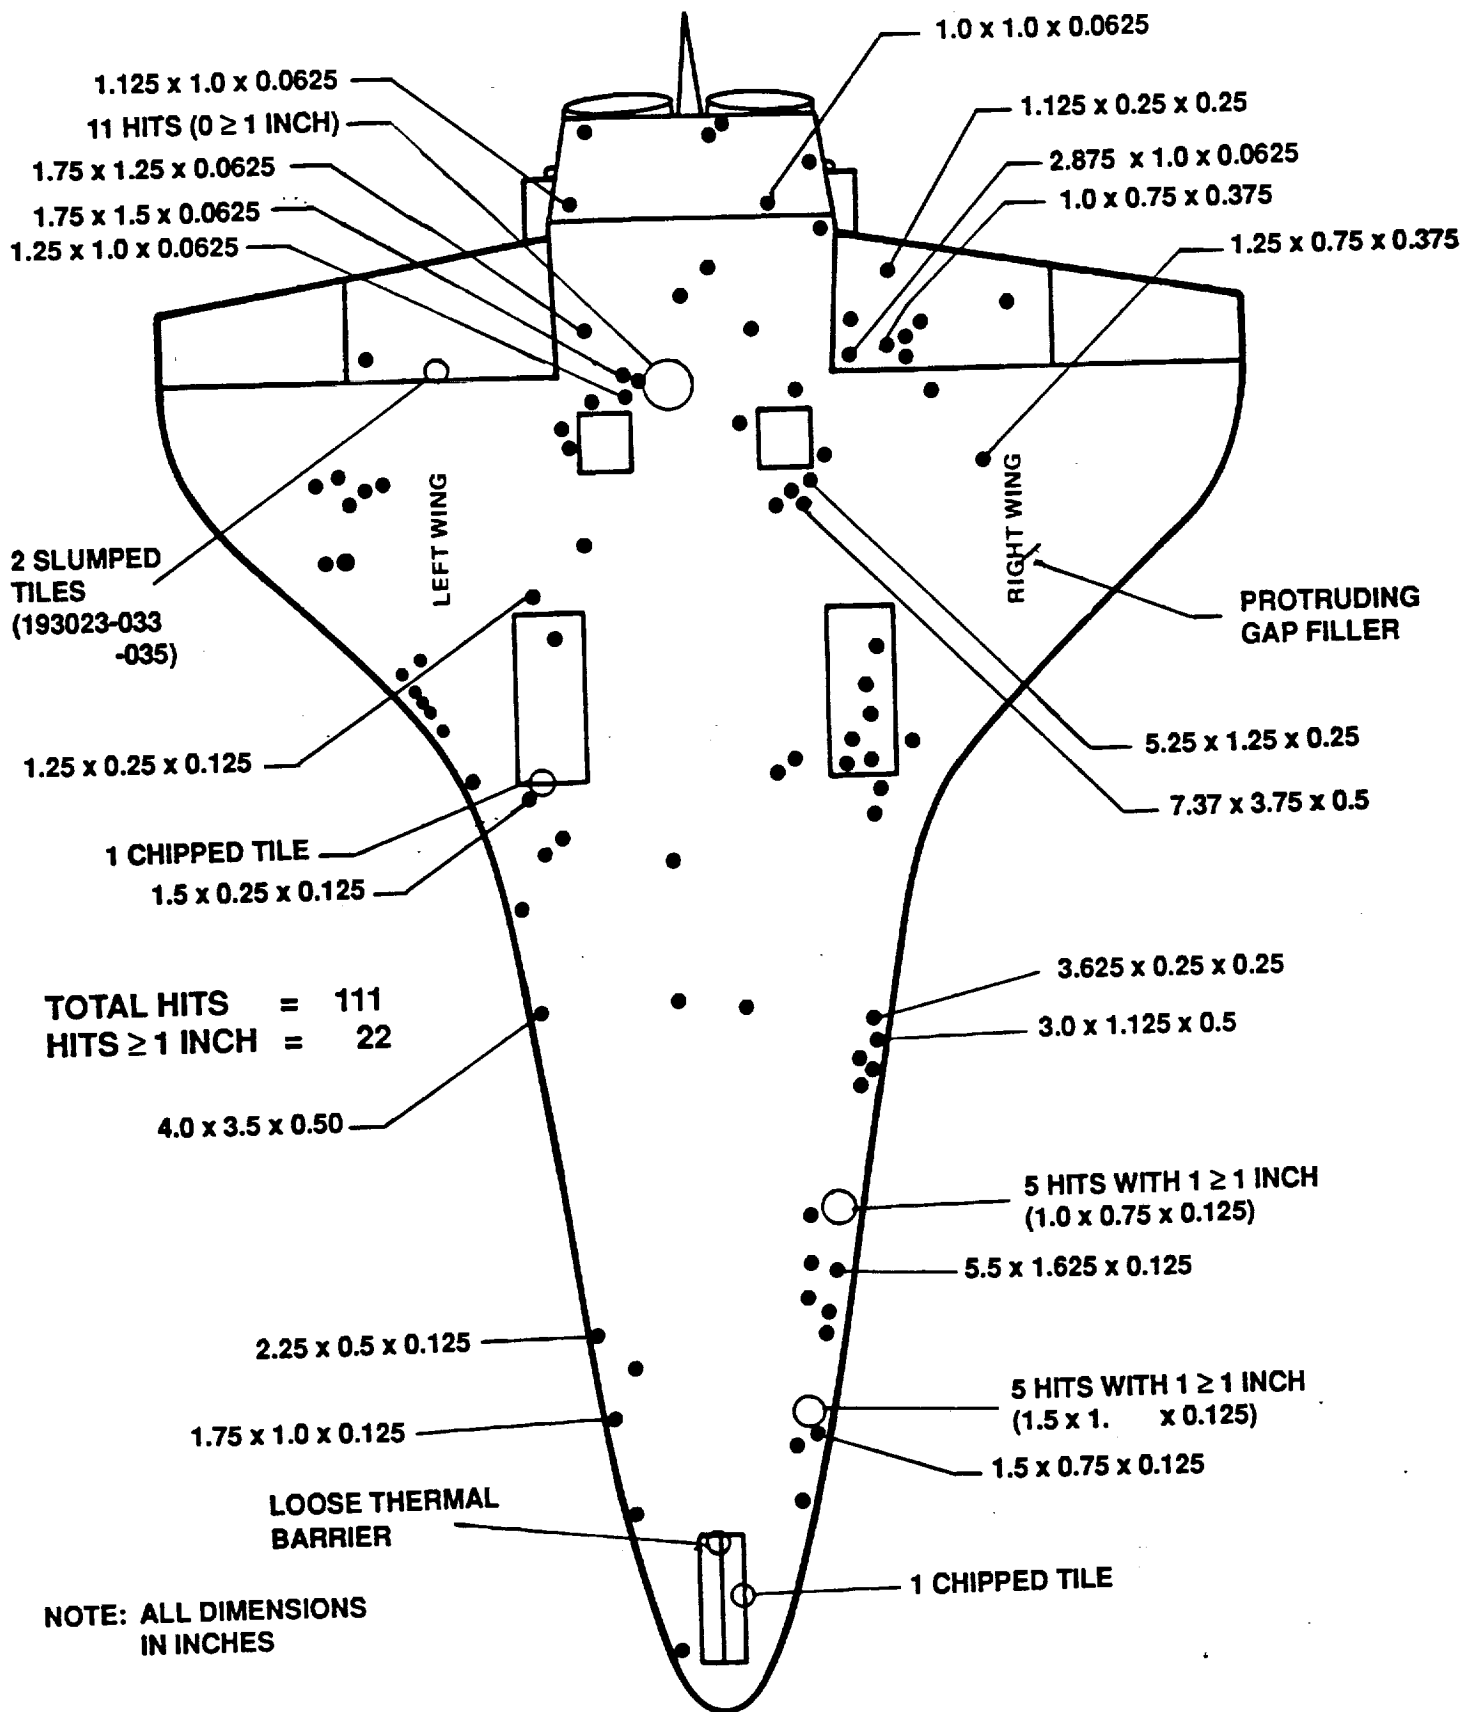
Figure 4 : Orbiter Lower Surface Debris Map

In summary, both the total number of Orbiter TPS debris hits and the number of hits 1-inch or larger was slightly greater than average when compared to previous missions (Figures 8-9). The type of TPS damage was typical and not attributable to any single debris source.

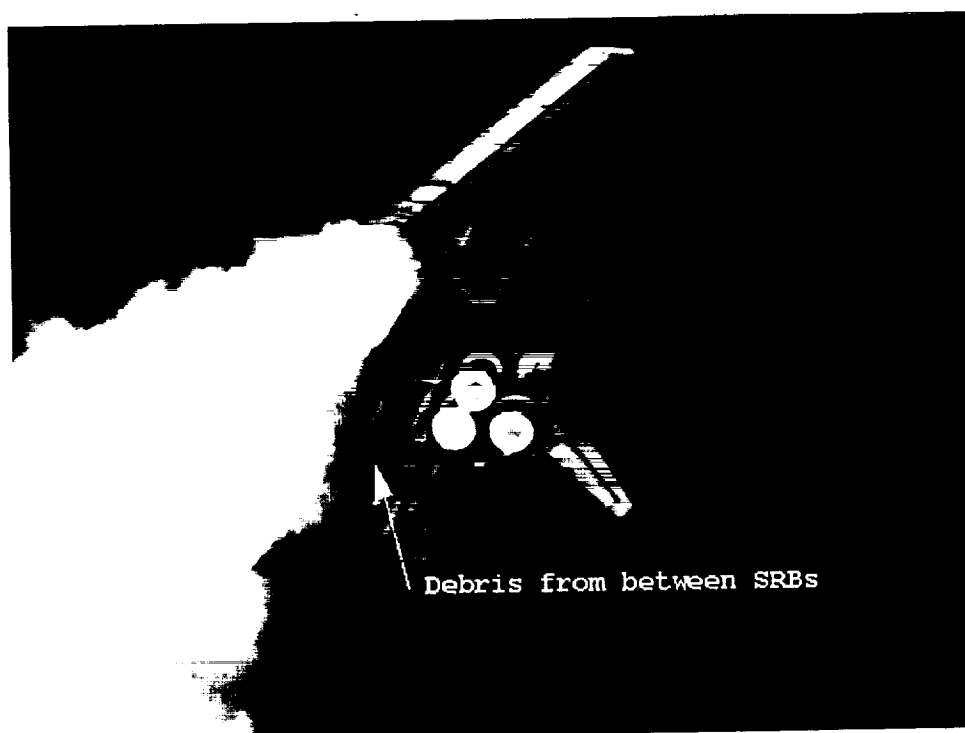
A debris particle was observed between the SRB's, aft of the ET aft dome, and became entrained in the SSME plume creating

a large flare in the plumes at T+25.07 seconds. This event was recorded by camera E-213 and is shown in Figure 3 and Figure 4.

Figure 3 Debris particle between SRB's

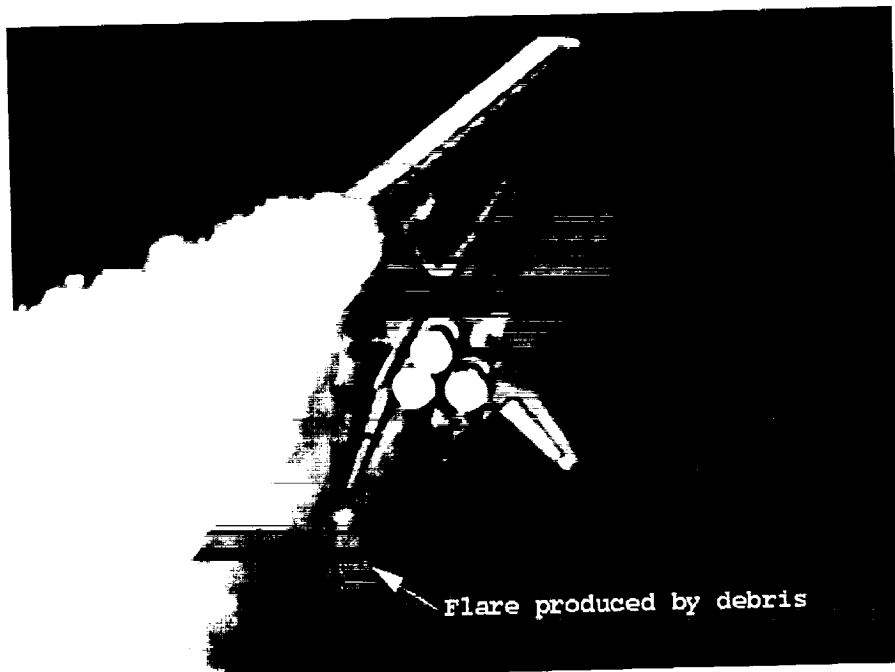
Figure 4 Debris particle in SSME plume

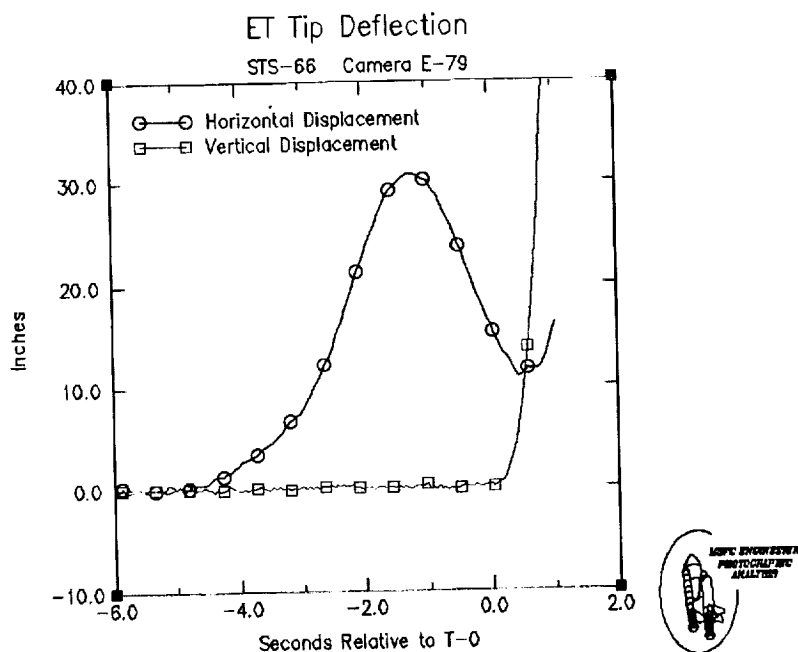
Figure 9 ET Tip Deflection

Maximum ET tip deflection for this mission was determined to be approximately 31 inches. Figure 9 is a data plot showing the measured motion of the ET tip in both the horizontal and vertical directions. A positive horizontal displacement represents motion in the -Z direction. These data were derived from film camera E-79.
